Site Address: Anglican Church/Parish of St.John the Divine  
#1930 Diamond rd.  
Garibaldi Estates  
Squamish, BC

Aug03/2022

**BELL TOWER- EXTRAS REPORT #5**

Re: **Extras: Hidden Damages Report and Summary @ Upper Structure**

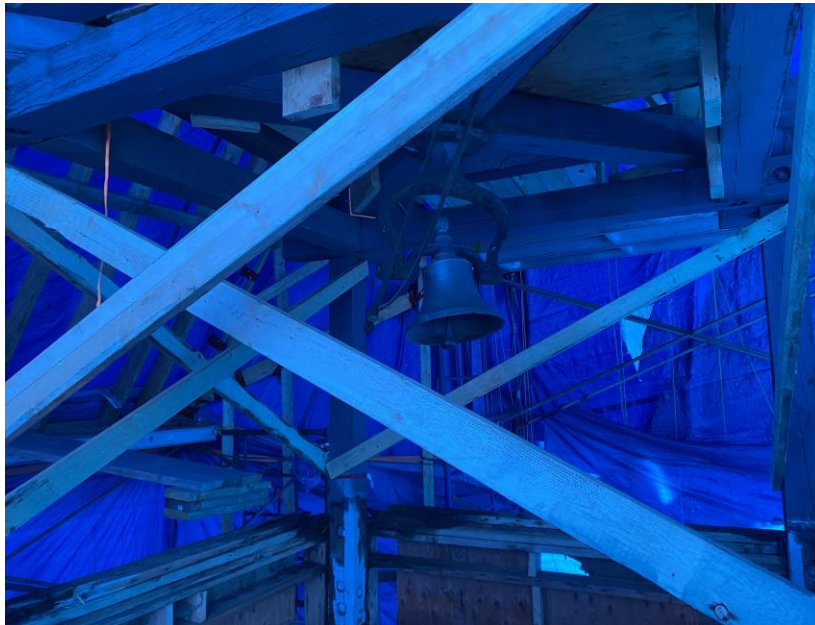
**Problem:** As seen in the work recently completed “below” the existing skylight elevation there are structural framing issues.

The existing frame stud work is sporadic and does not align with each other. This is a direct contradiction to The BC Building Codes. This is part of the tower “swing” problem.

**Solution:** Reframe and upgrade to meet all required structural requirements and BC Building Codes.

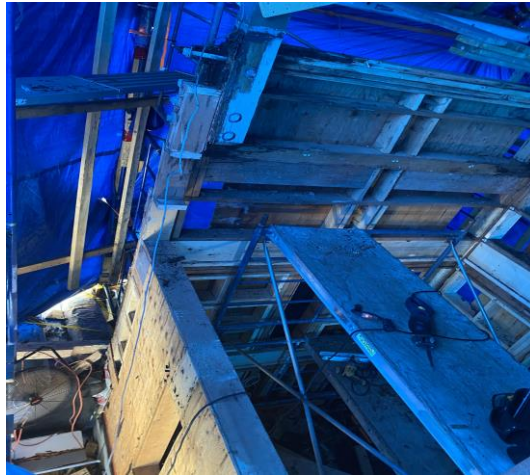
**Problem:** As seen in the lower tower elevations, the current frame work has been installed lying on the flat. This is at the lowest strength residence and allows for the wood to ``bow`` compound this with the details mentioned above and this all contributes to the heavy structural movement and fatigue.

**Solution:** Reframe and upgrade to meet all required structural requirements and BC Building Codes.

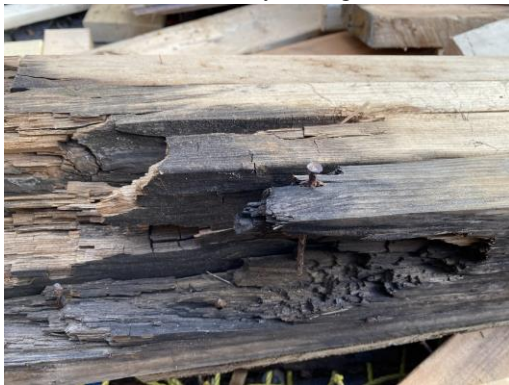
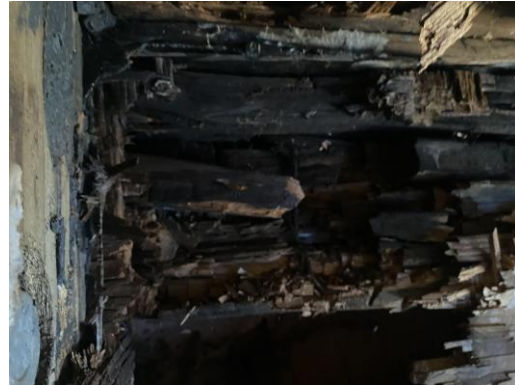
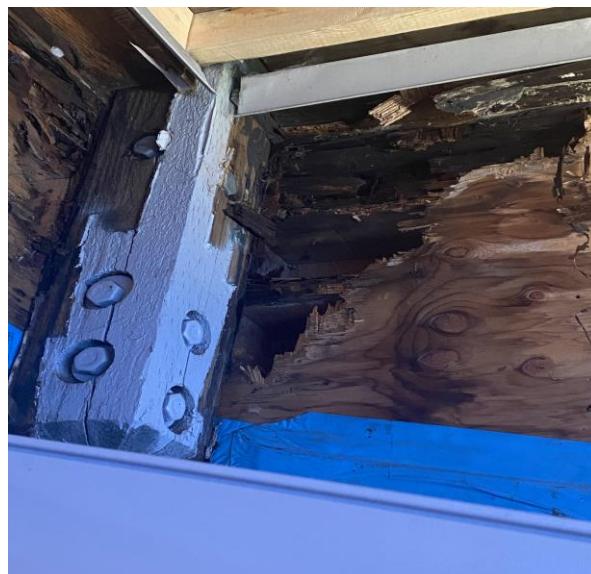
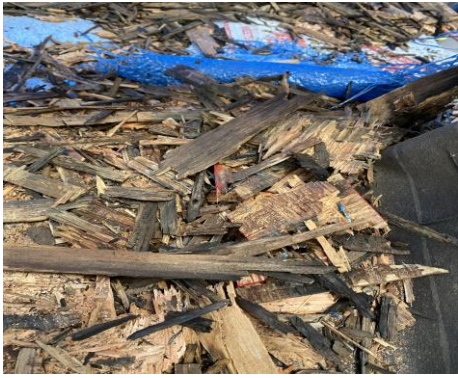
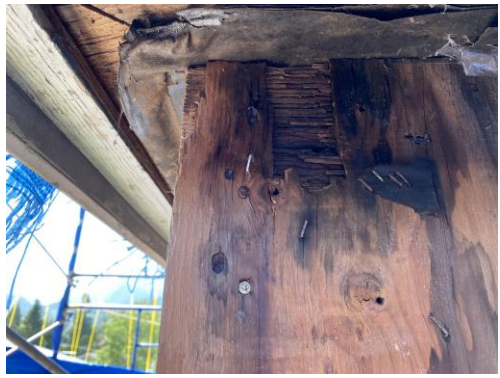
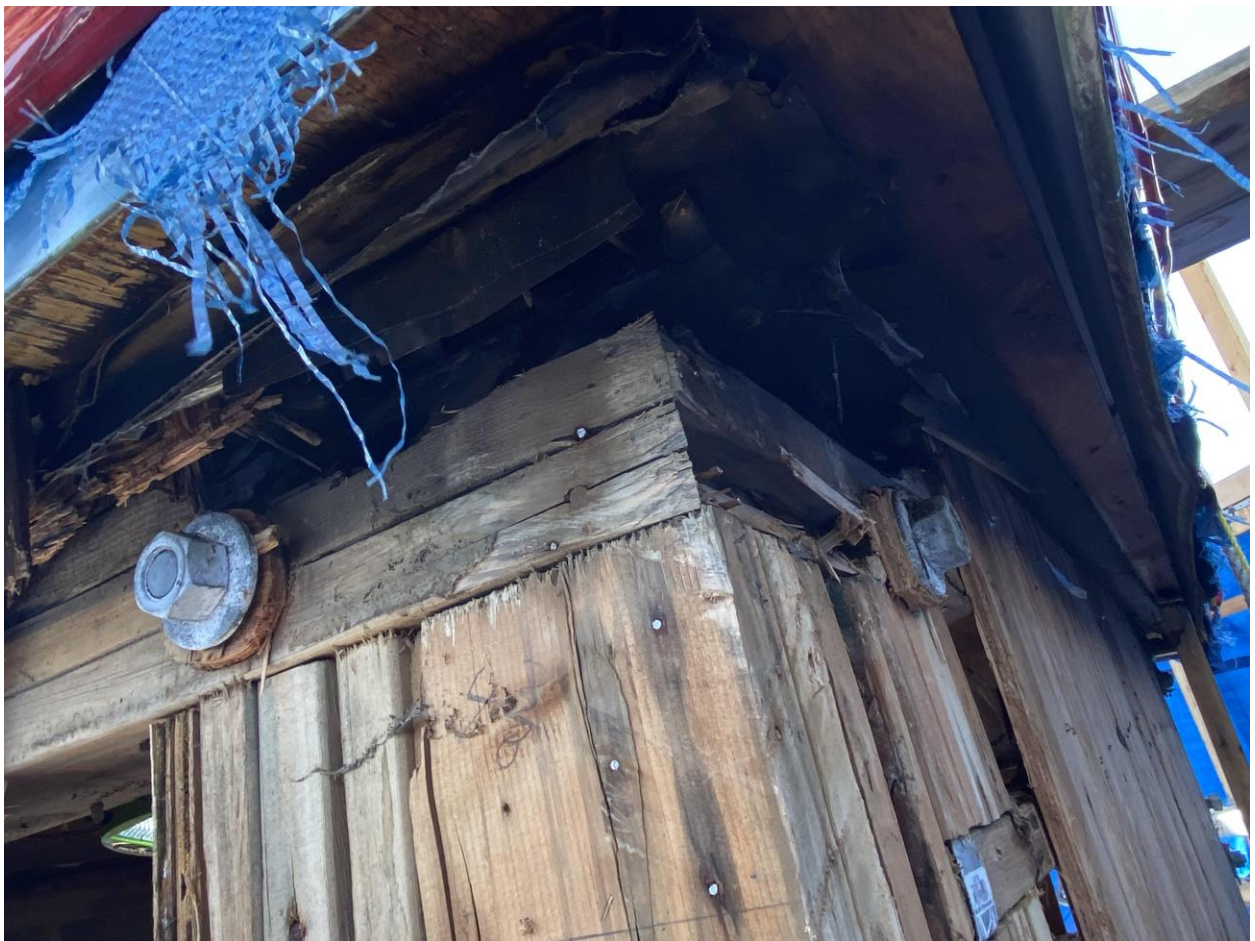
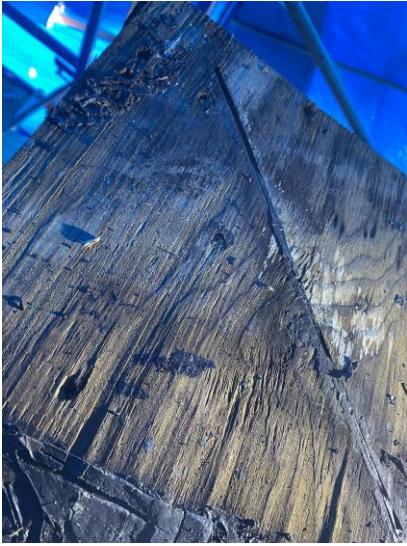
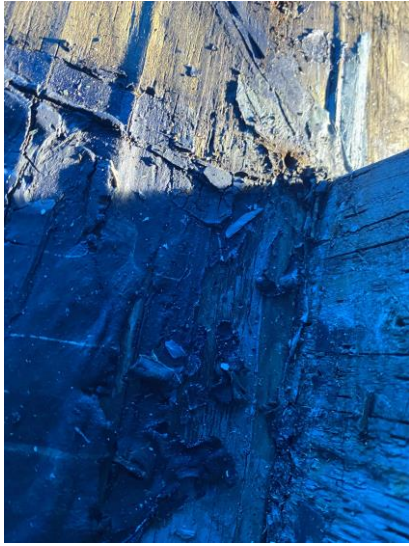
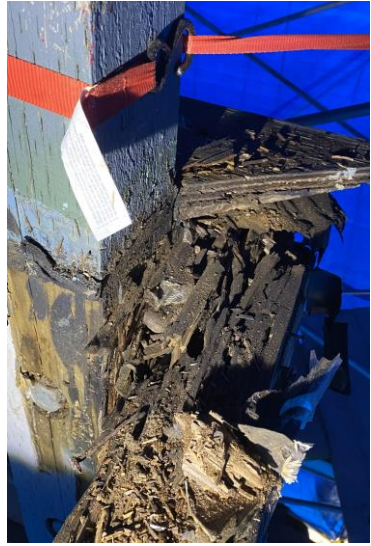
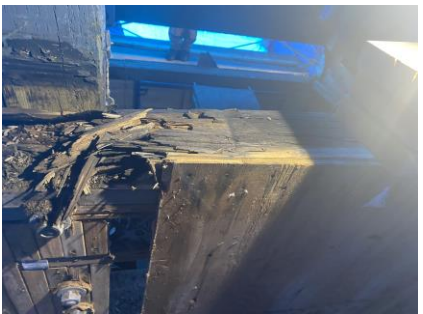
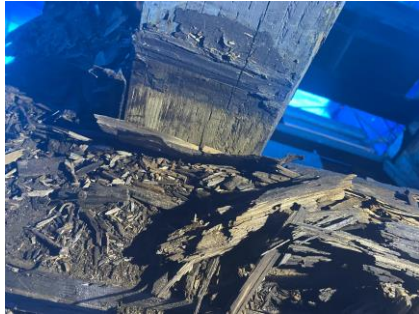
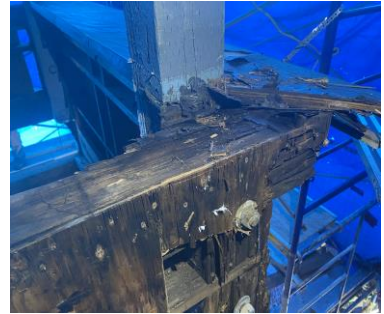
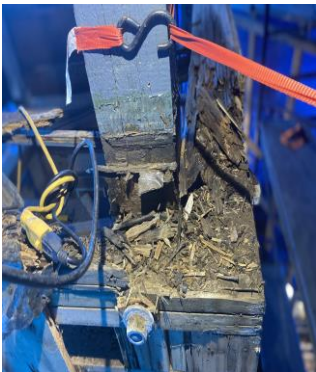
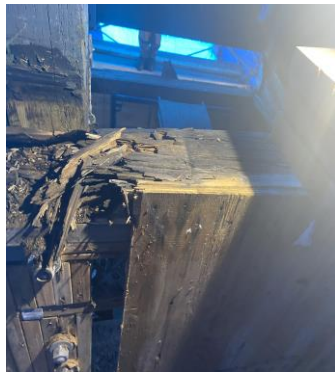
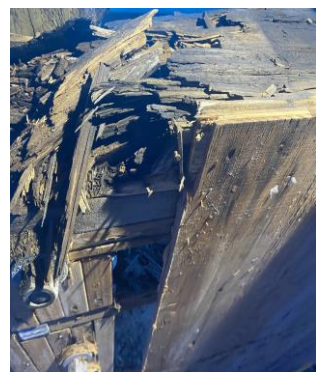
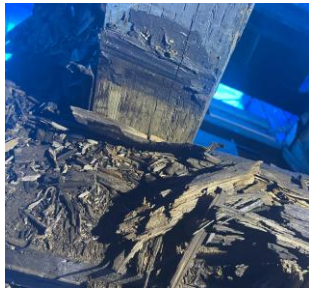
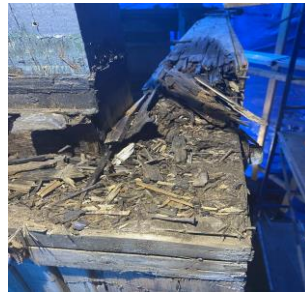
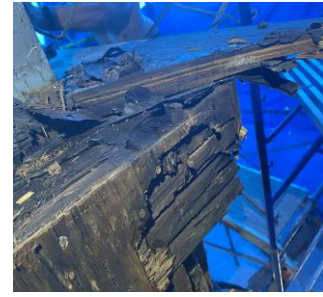
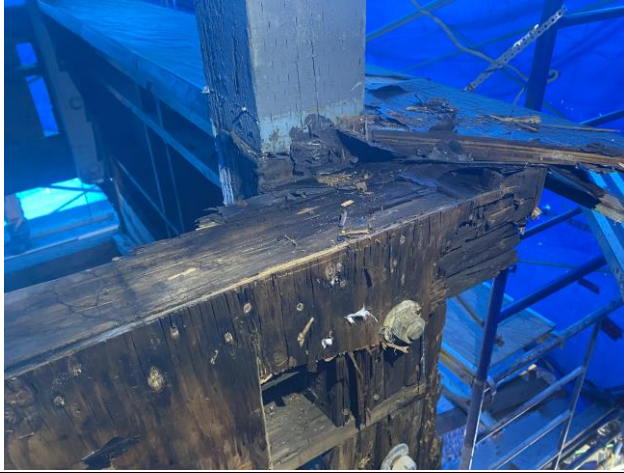
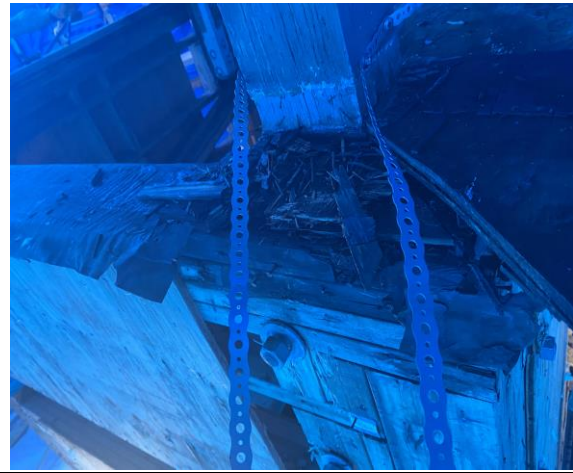
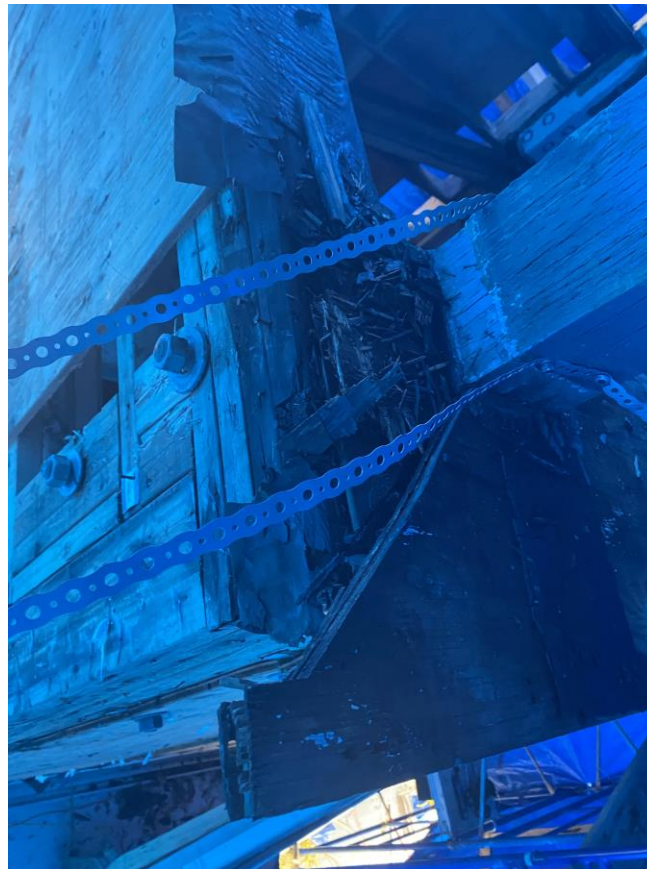
**Problem:** Due the longevity of water ingress over the years the existing structural framing at and below the timber work has sustained heavy damages. Saturation and dry rot has replaced the once strong fibres in the wood.

Some areas have turned to dust. While others have become brittle and are at a full failure capacity. All corners have sustained heavy damages.(x4).

**Solution:** Reframe and upgrade to meet all required structural requirements and BC Building Codes.

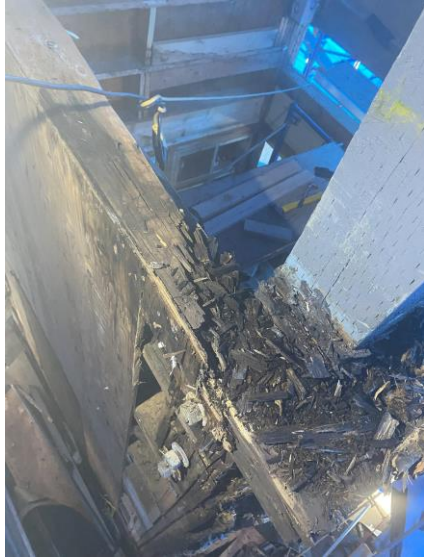
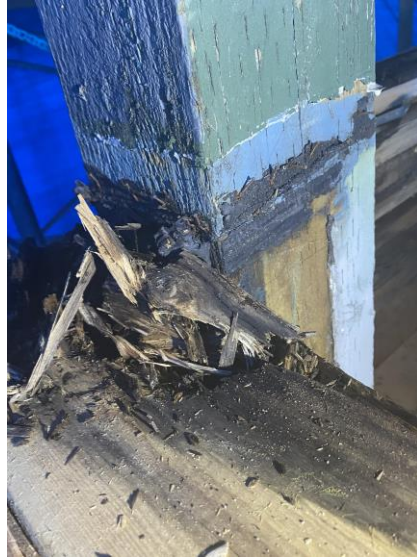
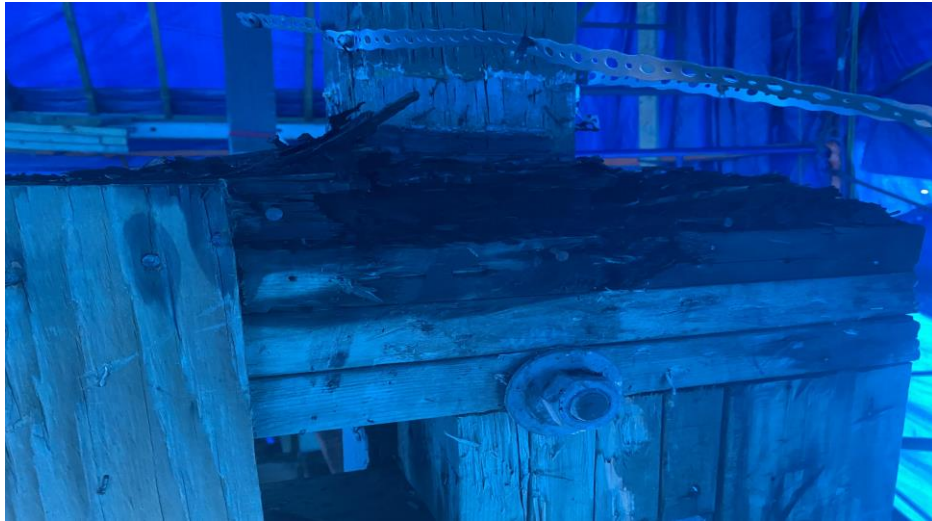
**Problem:** The damages at the top of the bell tower wall assembly are significant. The upper wall has had water ingress in several areas, this has led to these damages. The biggest culprit to these elevations demise is the poor detailing at all the timber to parapet junctions.

Over time there had been attempts to stop the flow of water from entering into the structure. This was mostly to no avail.

**Solution:** Reframe and upgrade to meet all required structural requirements and BC Building Codes.

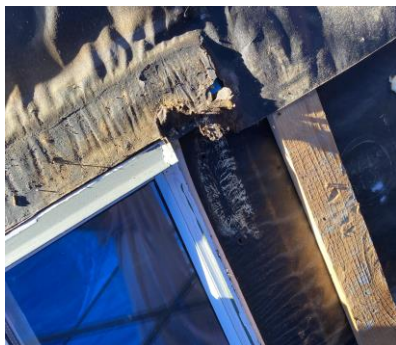
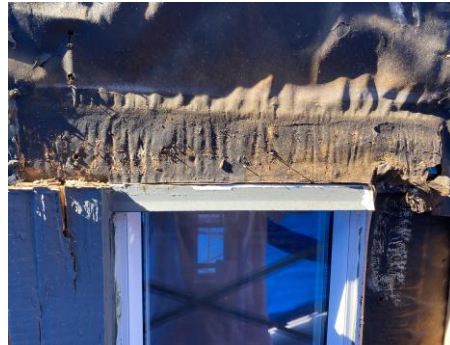
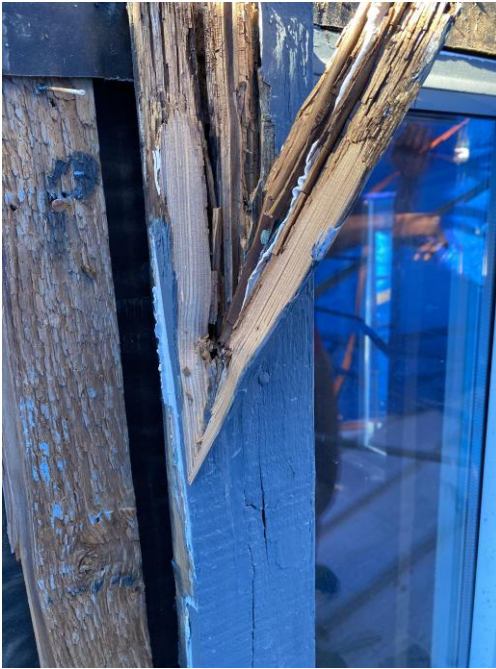
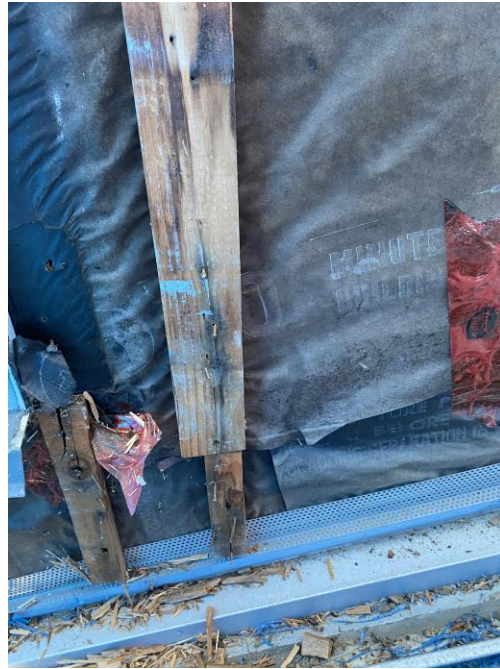
**Problem:** There are heavy damages at the south window elevations.

**Solution:** Reframe and upgrade to meet all required structural requirements and BC Building Codes. Meet or exceed all RCABC codes and best practices.

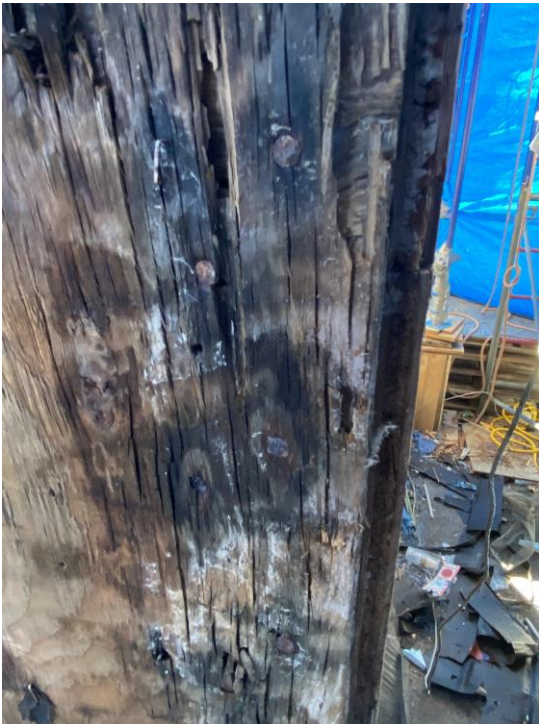
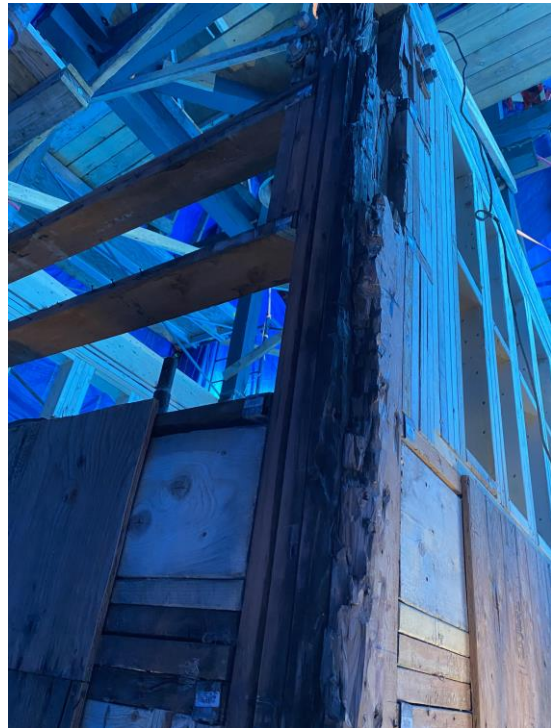
**Problem:** All the existing structural corners have substantial damages due to water ingress.

**Solution:** In order to do these repairs the timbers and the timber structure needs to “braced” and “shored” up in order to take the full above weight capacity.

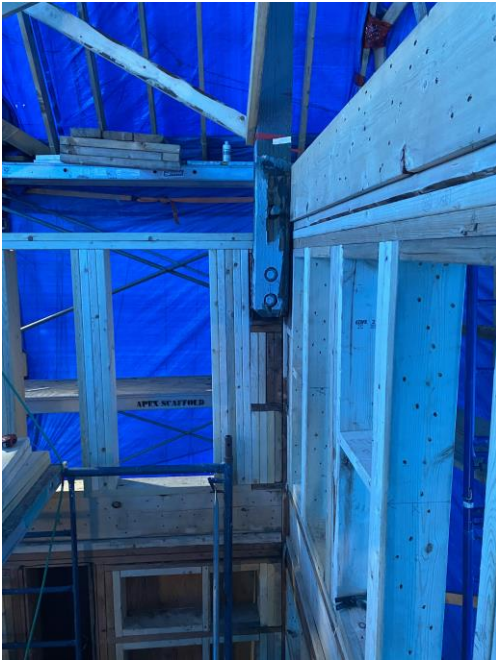
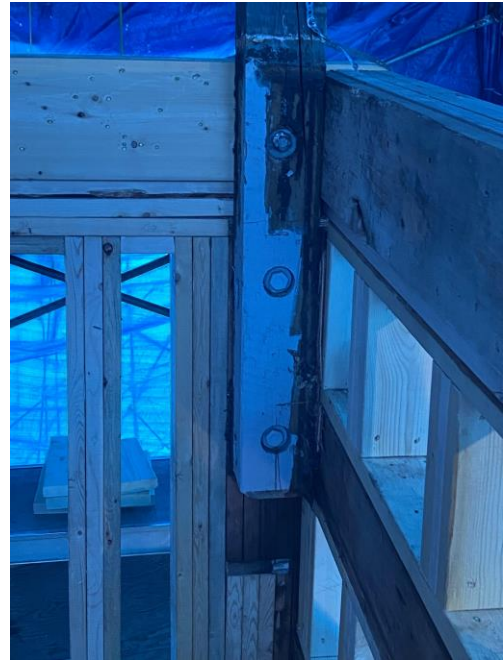
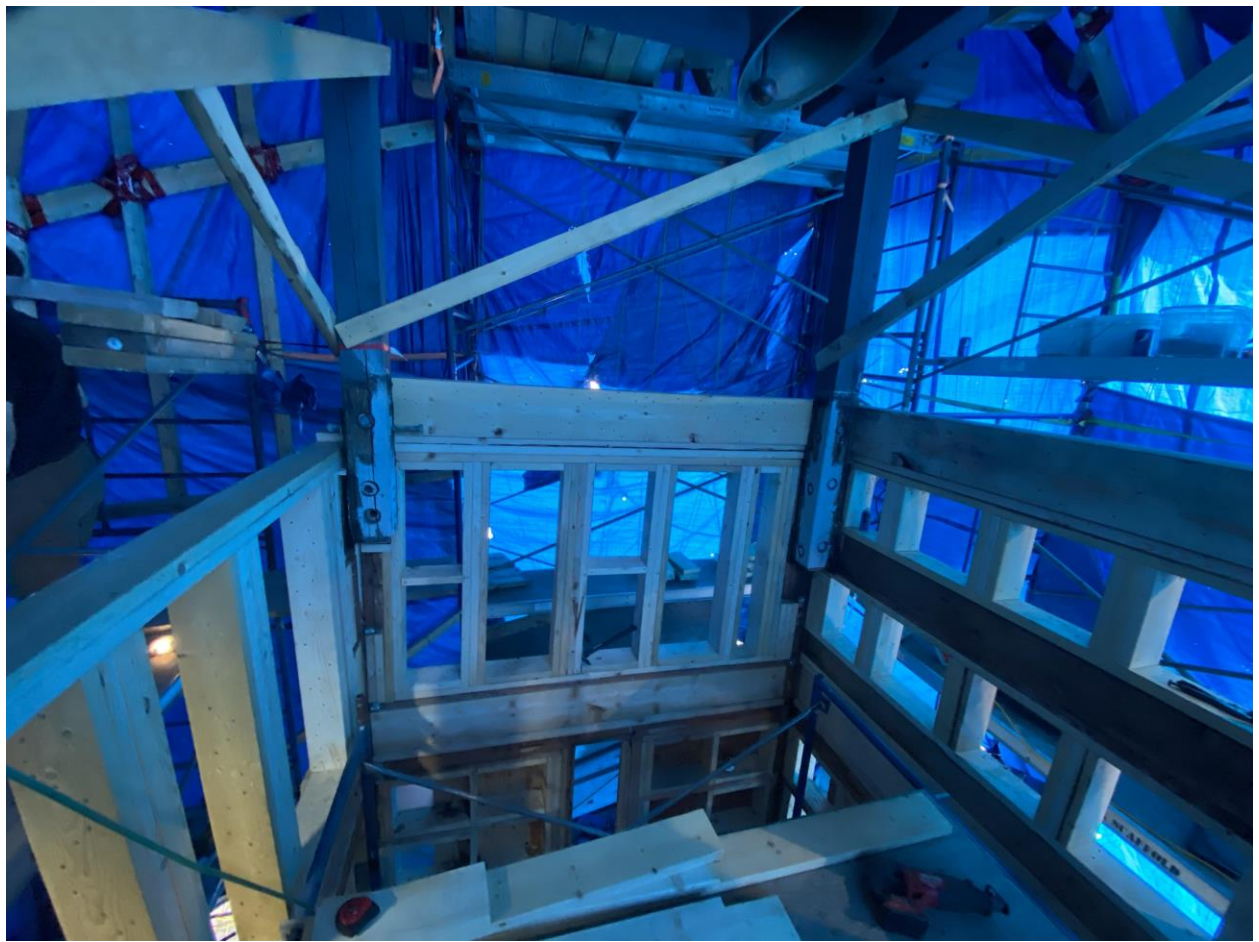
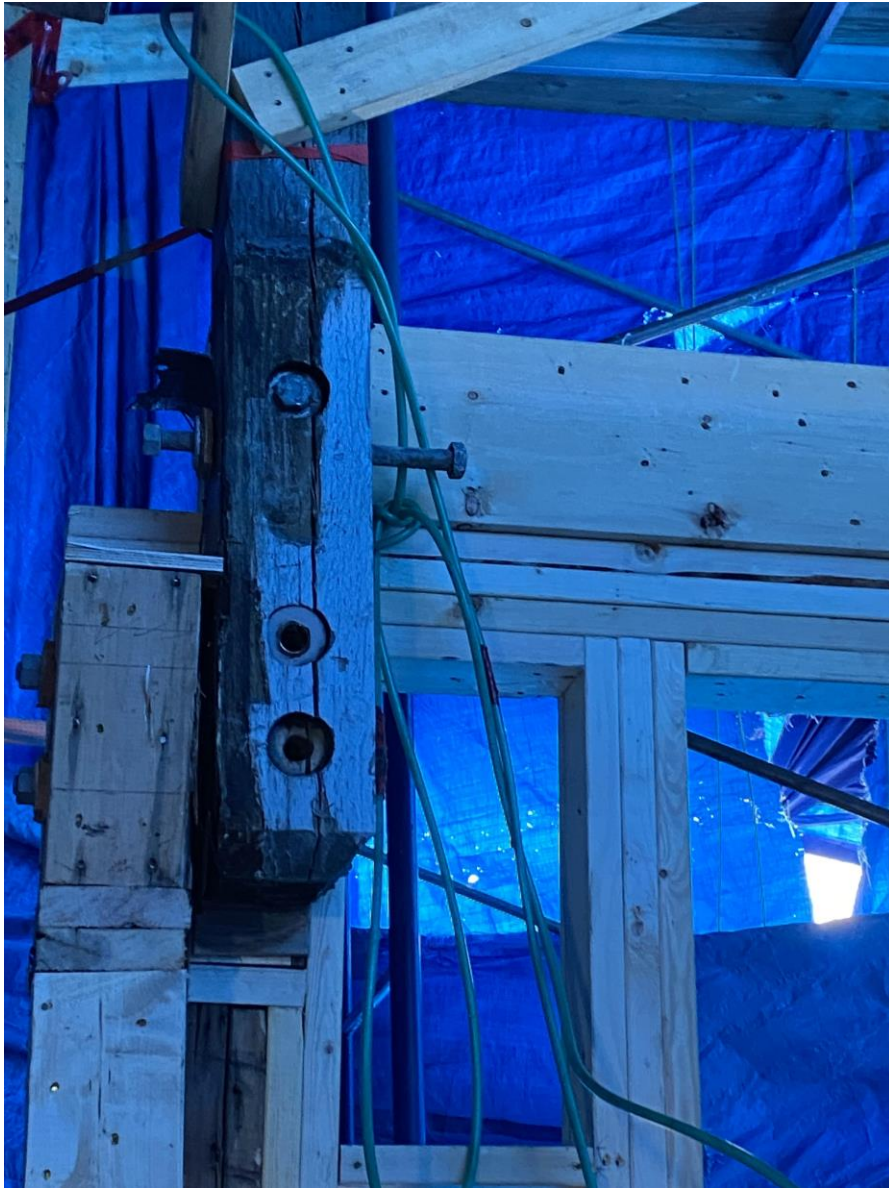
**Problem:** The existing timbers lean and/or spread at the lower elevations.

**Solution:** The temporary use of shoring jacks and bracing is needed to correct this problem. Once the structure is up righted the solution maybe to install some “new” timbers at the lower elevation of the timbers. These are to act as a xxl spreader block and hold the entire unit in place. This will prevent any future spreading.

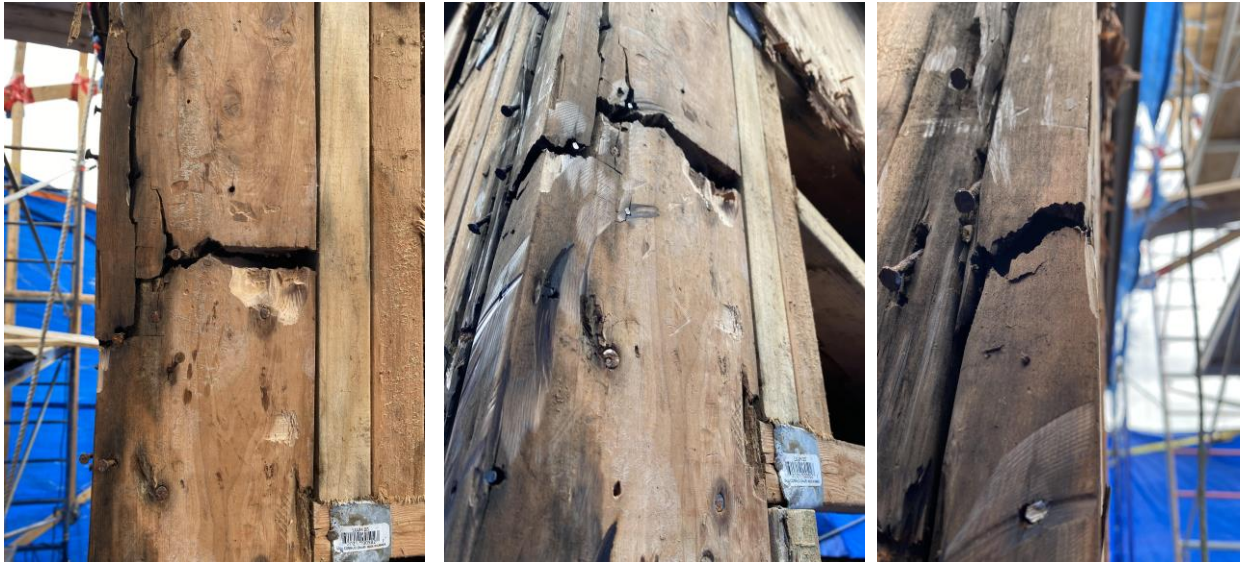
**Problem:** The devastation is so great in some areas that the combinations of heavy sway, water ingress and lack of seismic consideration has actually cause some of the structural corners to “crack” in half, leaving the full weight to be displaced on the wall framing only.

**Solution:** Reframe and use the proper seismic fore thought into completing these areas. The BC Building codes and best regional practices need to be implemented here.

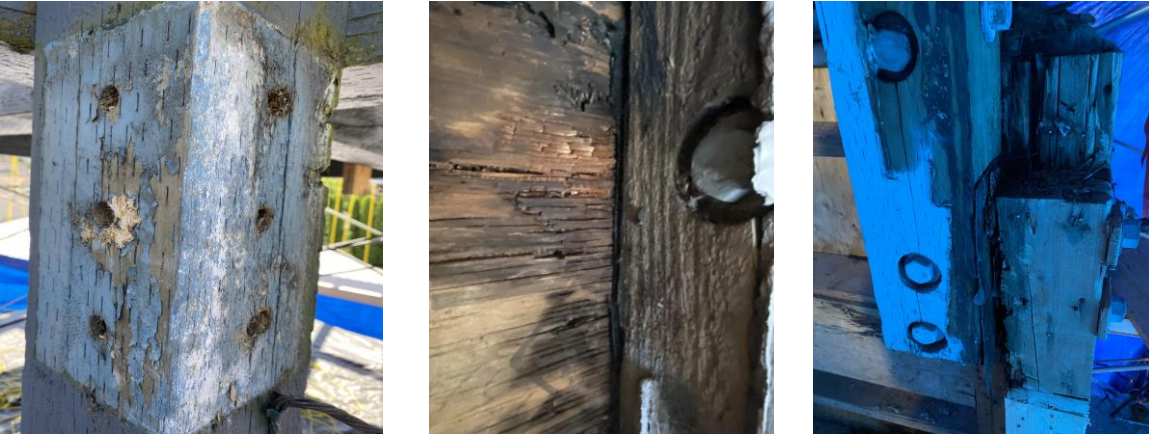
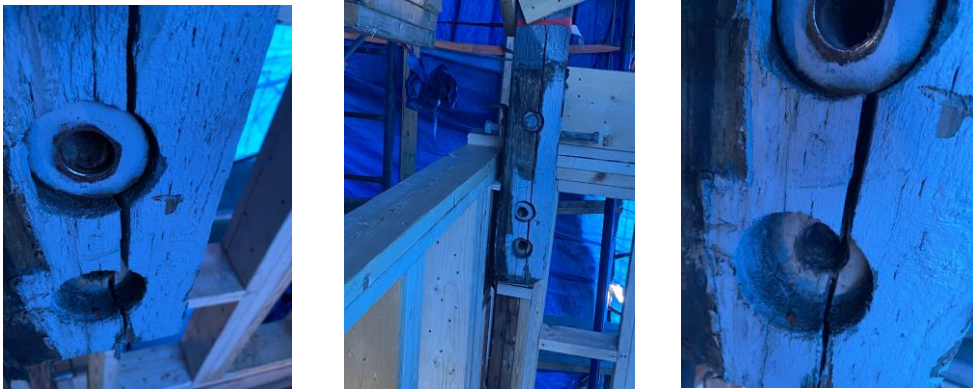
**Problem:** The bolts holding the timber structure to the tower assembly are starting to wear. Partially due to the above mentioned, as well as water gaining “breach” to the holes.

**Solution:** Treat the holes with anti- rot and petrified solution. Install synthetic structural wood filler and re drill rot the existing bolt pattern. Then seal each “new” hole with the appropriate caulking sealant.

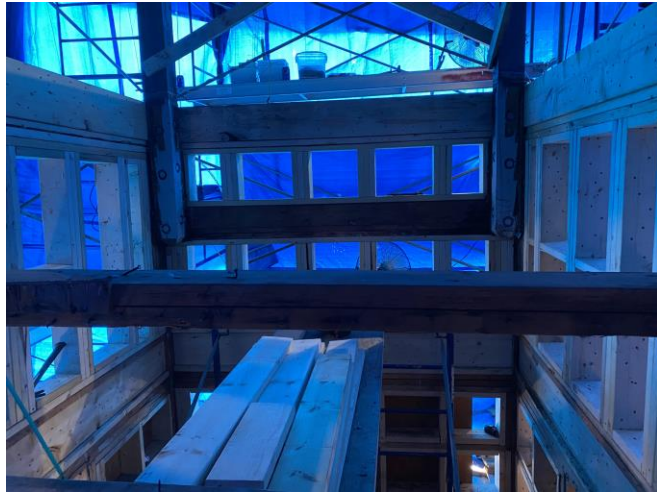
**Problem:** The overall height of the timber/bell tower assembly exceeds the maximum height rational for the internal timber length and support. This also is a big contributor to the assemblies negative out sway.

One side of the structure the timbers are on 24" into the structure, the other side is 36". All these should be a minimum of 6' below the top curb into the structure.

**Solution:** In conjunction with the above mentioned, the existing timbers should be extended and "new" heavy duty tower bolts and hardware applied. Since is now going to inside and visible this in turn would need to have a finished product install to hide the "new" work.

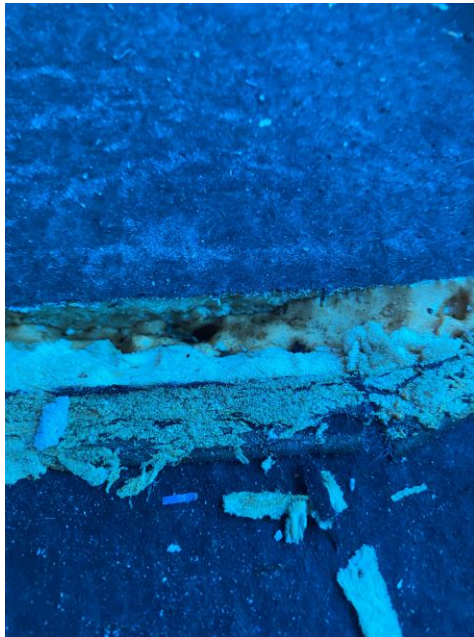
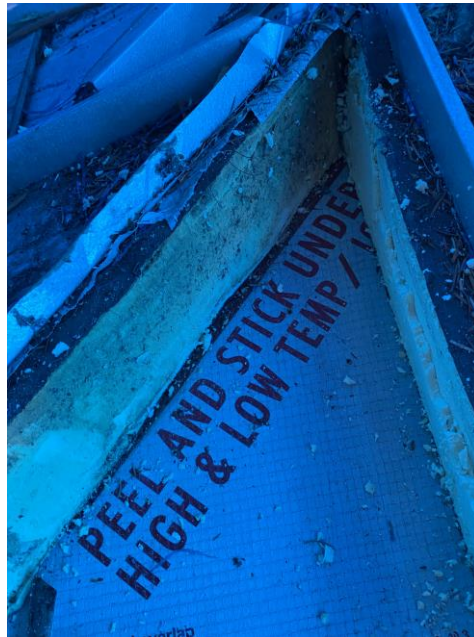
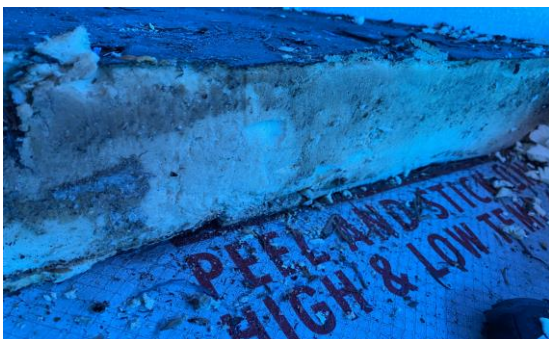
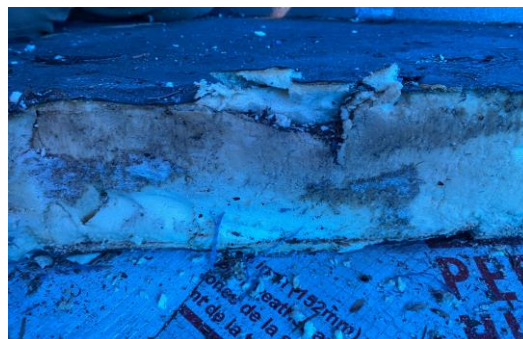
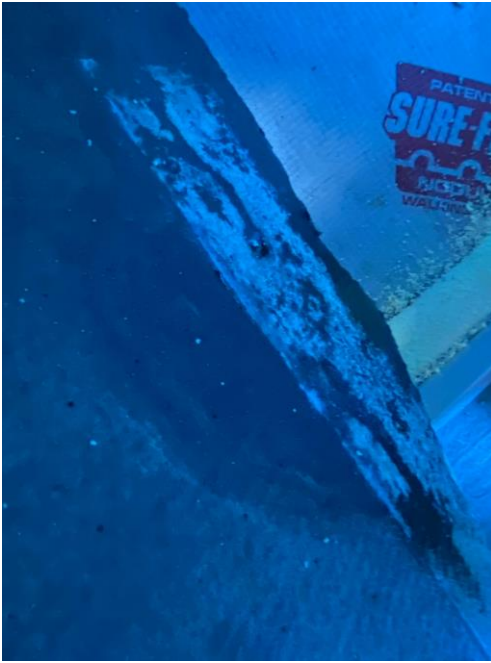
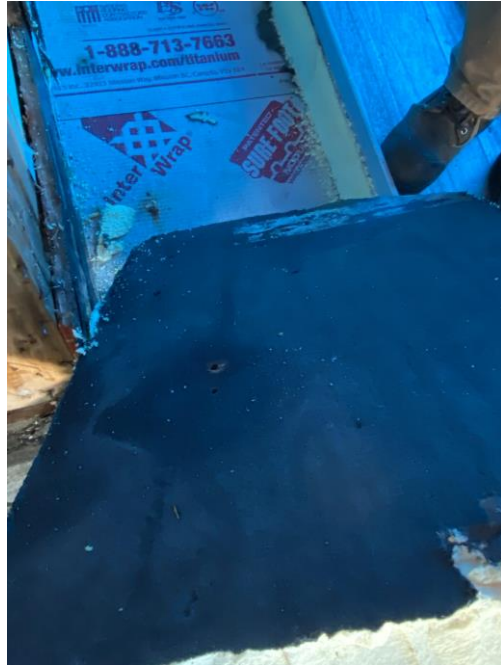
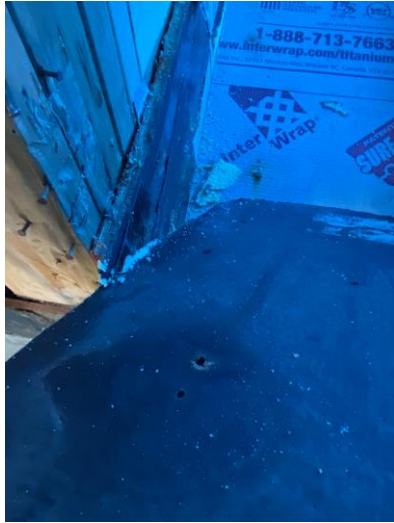
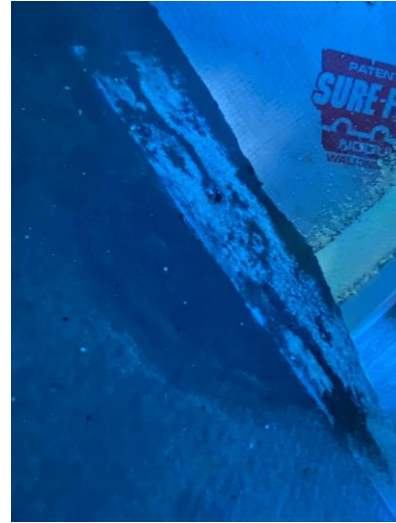
**Problem:** During the demo process it was discovered that the existing ISO insulation at the tower junction was saturated. It is so heavy it was breaking under its own weight when being removed.  
There has been a substantial rain in approx 4-5weeks.

**Solution:** Find the leak source and eliminate it and install new product.

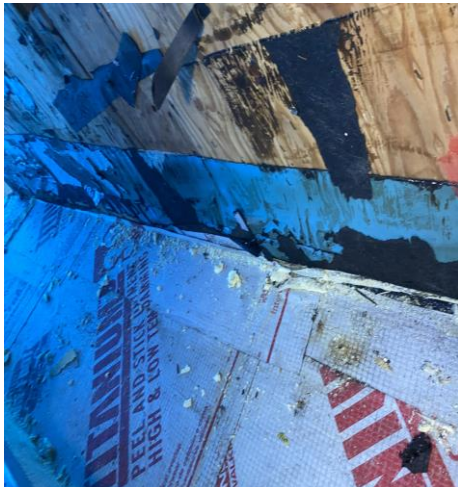
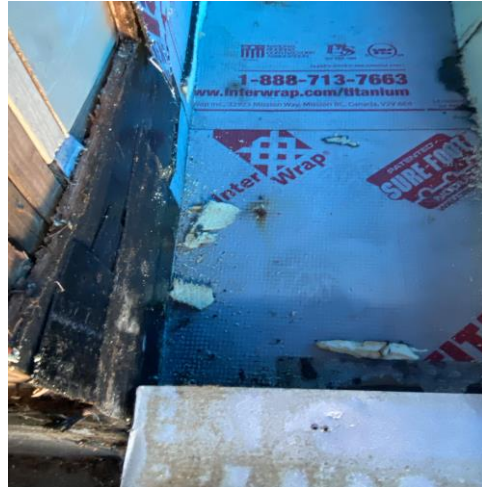
**Problem:** Not only is water running below the insulation, but it is also making its way between the existing roof panel and the top side of the ISO insulation.

**Solution:** : Find the leak source and eliminate it and install new product.

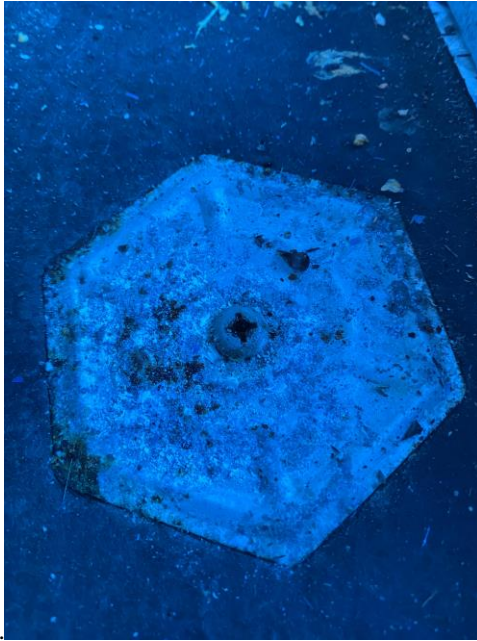
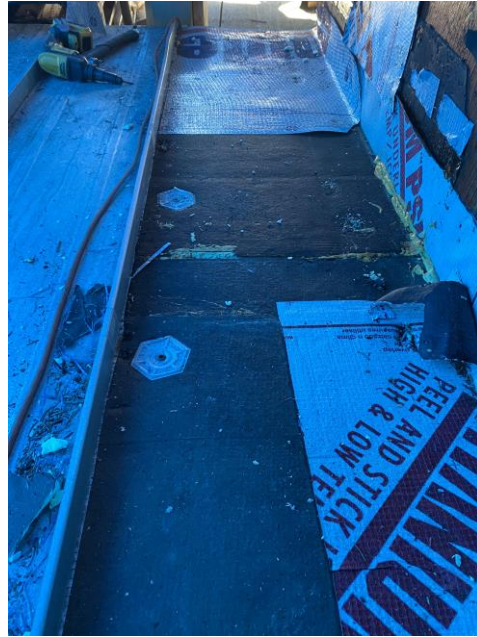
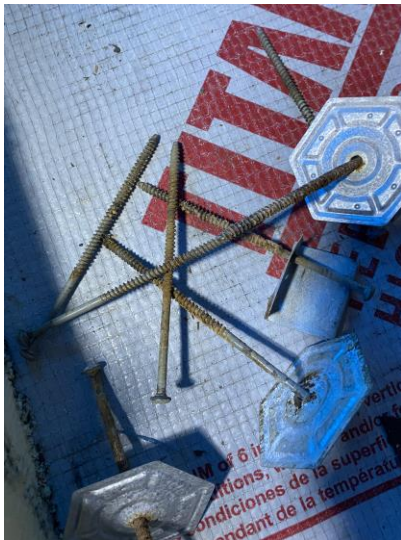
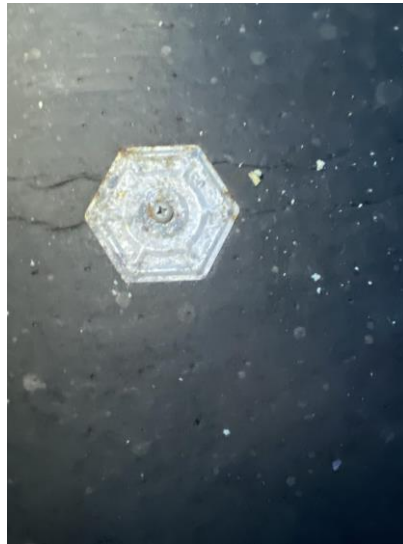
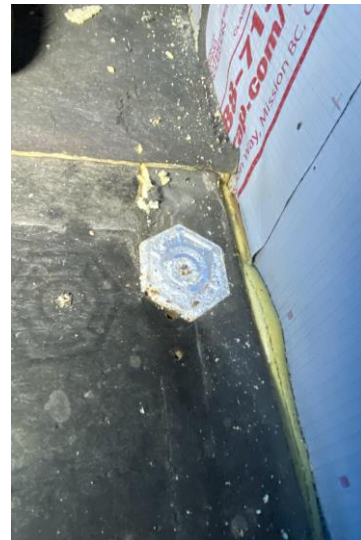
**Problem:** All the existing insulation plates and screws have been compromised are have a combination of regular and white rust.

**Solution:** Find the leak source and eliminate it and install new product

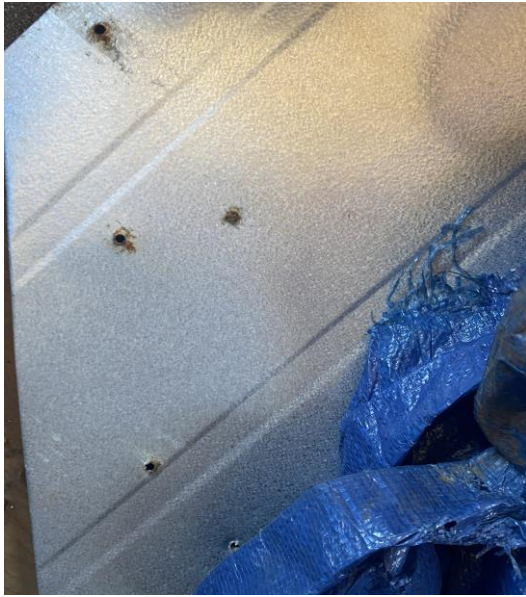
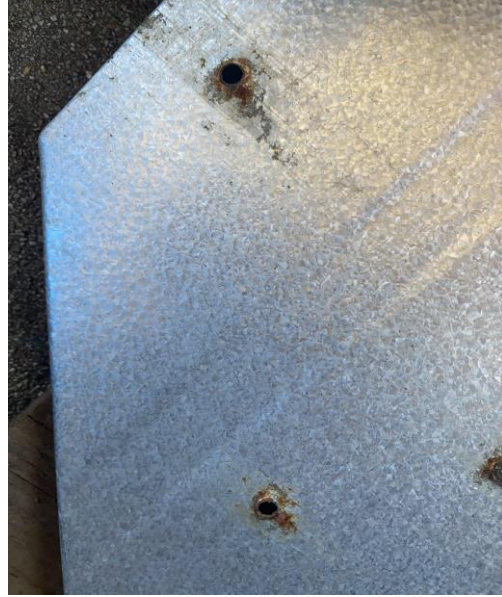
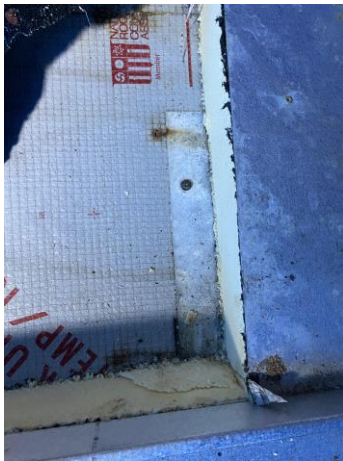
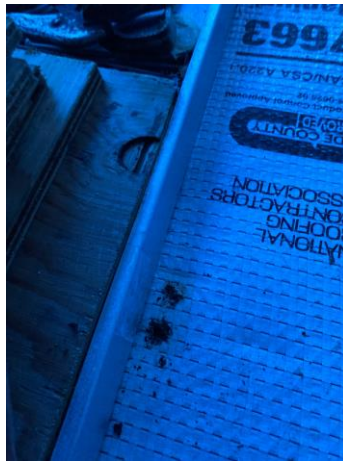
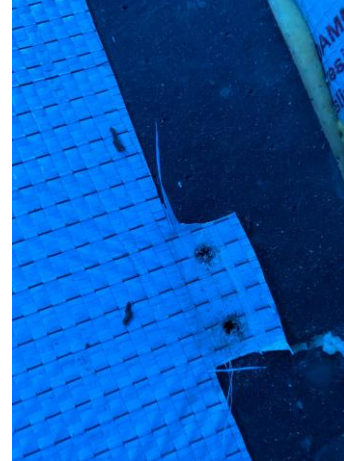
**Problem:** The original proponent has installed the roof panel with 6" insulation screws @ all clip and panel heads as the drag load fasteners. This is the complete wrong application for these screws. All drag load fasteners need to be self-sealing with a washer and sealing grommet. Since the existing has neither, water has been breaching at every screw head. This runs to the lower extremities of the structure, being absorbed by the ISO.

You can see the rust staining on the back side of the panels. This is an indicator to a leak source.

**Solution:** : Find the leak source and eliminate it and install new product. Install the proper sealed fastnars,

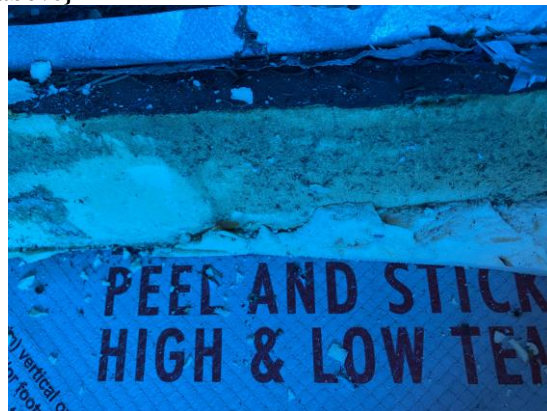
**Problem:** During the demo process@ the roof to wall elevation, it was discovered the appearance of heavy water staining and black mould on the existing ISO upper cut edges at the hip elevations. Upon further investigation the water sources seem to also be breaching at the above already mention details, however this runs the entire length of the main roof/sanctuary elevation.

During the investigation water staining is evident along all the internal beam work. This could from previous damages before the “newer” roof was installed or “not”.

**Solution:** Re-detail the entire hip and applied the proper technique to insure to meet all RCABC standards.

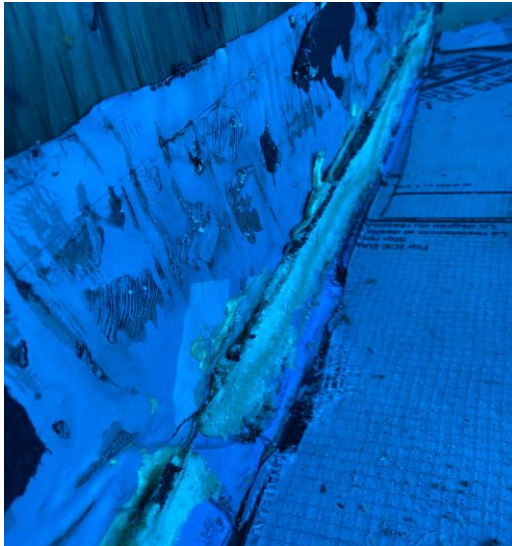
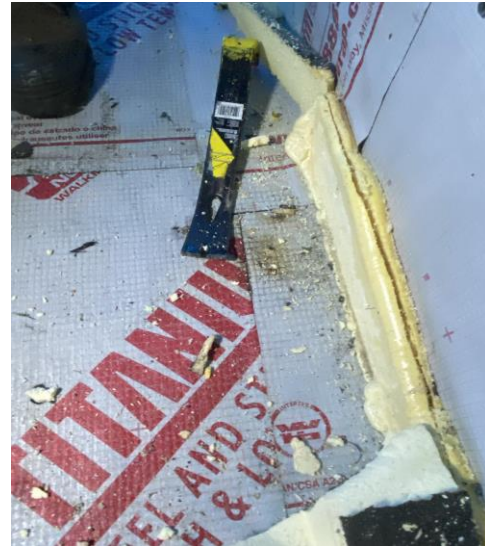
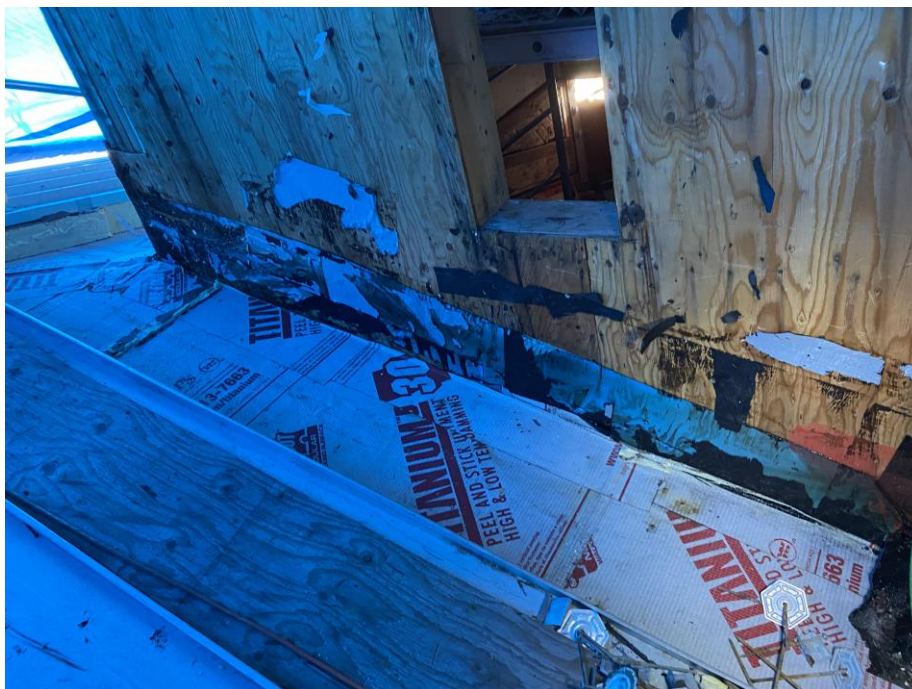
**Problem:** The contractor has installed the ice/water shield membrane below the ISO insulation and on too the tower wall assembly.

However, the installers must have known the product was either damaged or installed incorrectly. They have installed a spray foam insulation in areas and then tried to install a sealant over it.

The materials have several long slices in the product at the wall to roof intersect. This would suggest that the membrane was “webbed” in these areas and the installer had cut it to make it lay better. After which they had tried a failing attempt to water proof it.

This would further explain some of the water damages and water flow issues into the wall cavity and the structure.

**Solution:** Re-detail and apply the proper technique to insure to meet all RCABC standards.
