Site Address: Anglican Church/Parish of St.John the Divine  
#1930 Diamond rd.  
Garibaldi Estates  
Squamish, BC

Aug03/2022

**BELL TOWER- EXTRAS REPORT #5**

Re: **Extras: Hidden Damages Report and Summary @ Upper Structure**

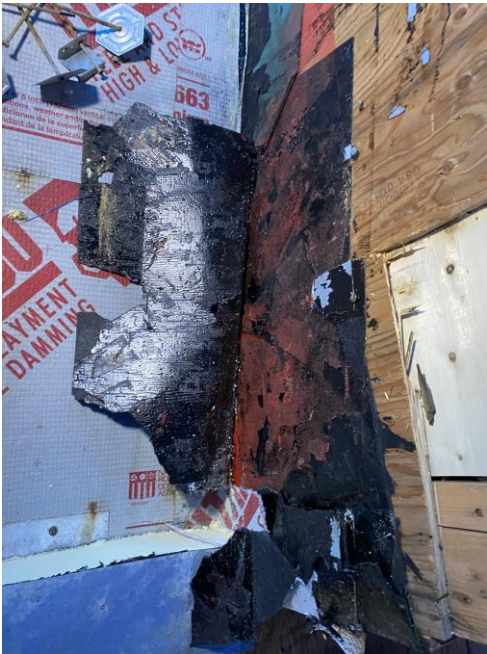
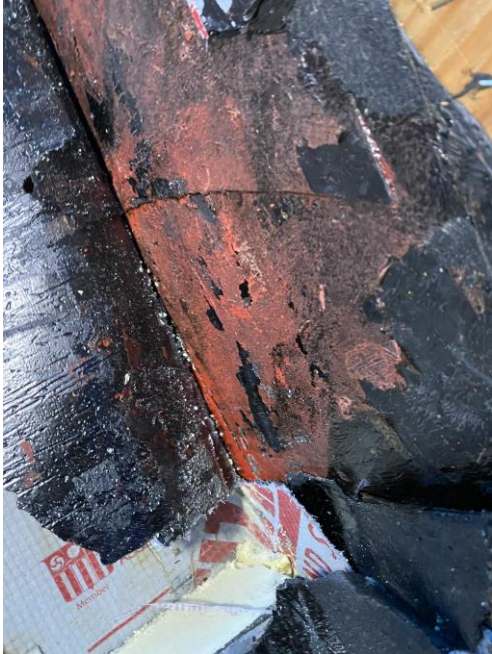
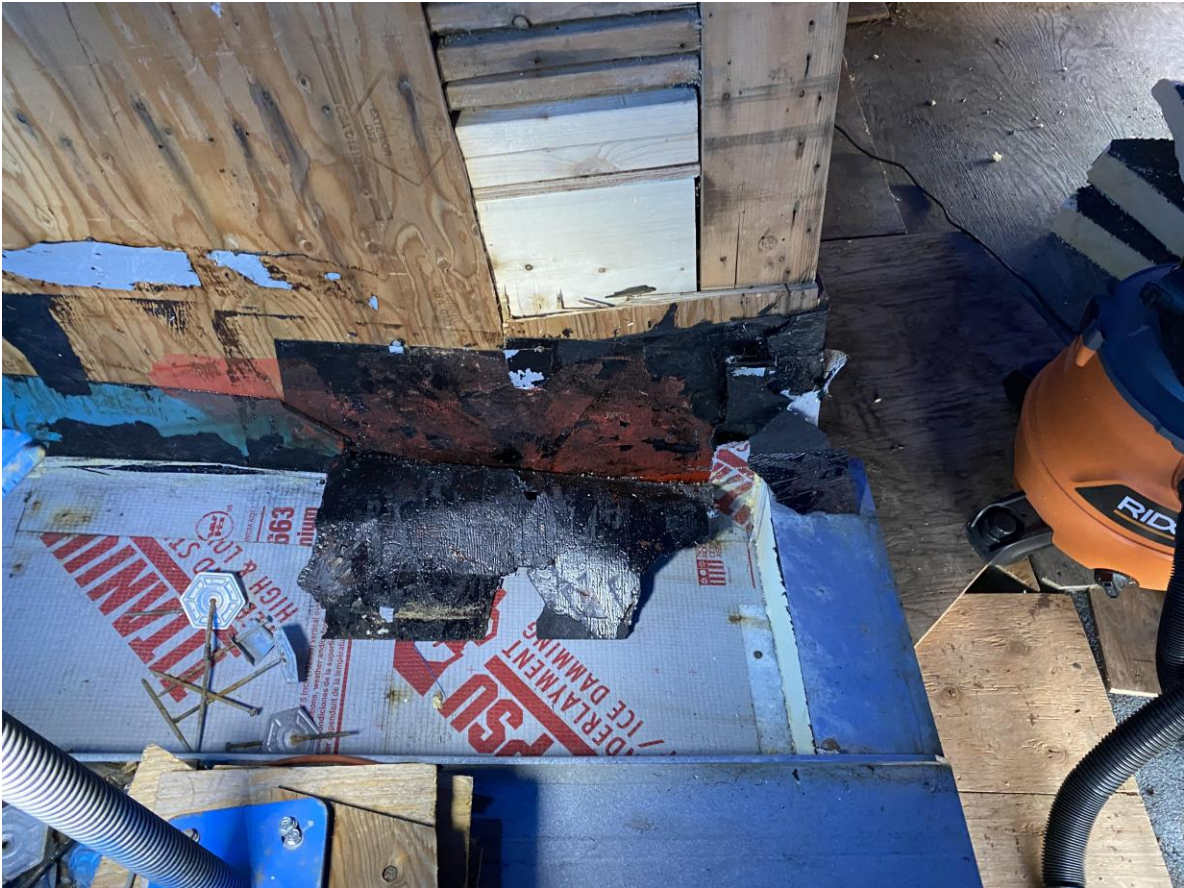
**Problem:** The contractor has installed a primer to the tower wall assembly wear the ice/water sheild has intersected.

However this has failed as bonding agent because the water and moisture have been generated from higher up and are also working its way from the backside of the plywood.

This would explain the ease it came away from the structure and was displaced. This then would also contribute to lack of waterproofing and the continue existing demise of the waterproofing system.

**Solution:** Re-detail and apply the proper technique to insure to meet all RCABC standards.

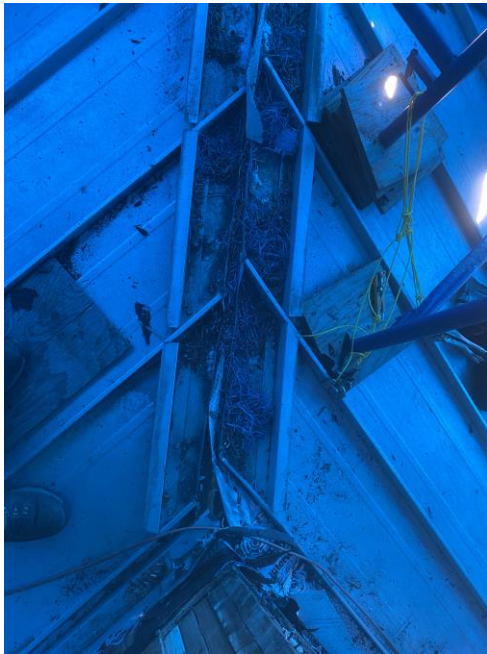
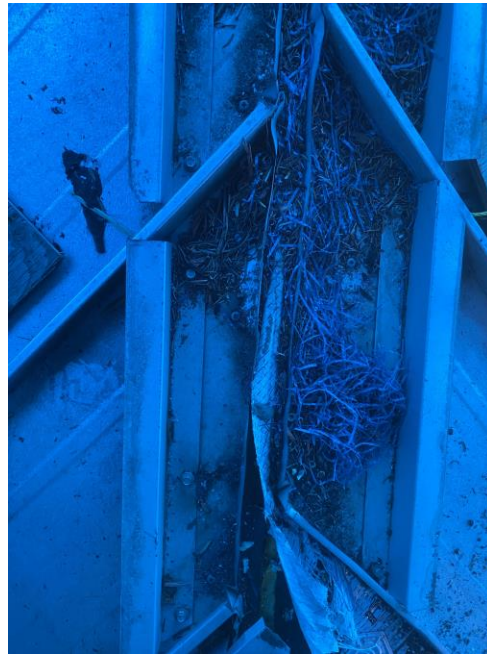
**Problem:** The is "0" universal closer at the hip elevation in its entirety. This product allows the building to breath while eliminating any blow-in. The hip as it is, is full of debris and critter tracking.

**Solution:** Re-detail the entire hip and applied the proper technique to insure to meet all RCABC standards. Clean this elevation in its entirety and install a breathable universal closure.

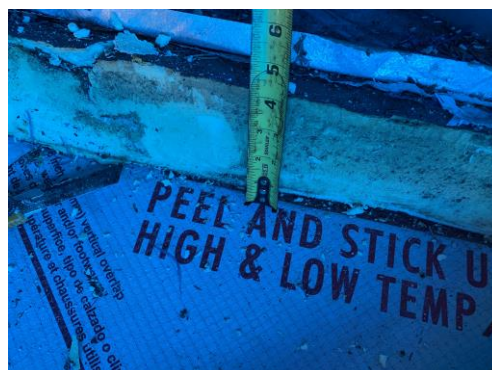
**Problem:** This final problem is a major one. The contractor has install what is known as a "built up roof system" This were you have the insulation and vapour barriers sandwiched in between the roof assembly. The insulation is above the frame work rather than in between or below it. When this system is built the ISO board is supposed to have an area space between it and the ceiling. This air space allows the building to breath. Without that it chokes the building and causes condensation and venting issues. Especially when an ice/water shield membrane is applied to the substrate, as is here. This can and maybe part of the issues above the bell tower elevation. There are definably issues showing to point towards these items. Saturation, even though it has rained and the appearance of mould on the edgeds.

**Solution:** Consider a deeper further investigation into these issues.
