Site Address: Anglican Church/Parish of St.John the Divine  
#1930 Diamond rd.  
Garibaldi Estates  
Squamish, BC

Aug03/2022

**BELL TOWER- EXTRAS REPORT #5**

Re: **Extras: Hidden Damages Report and Summary @ Upper Structure**

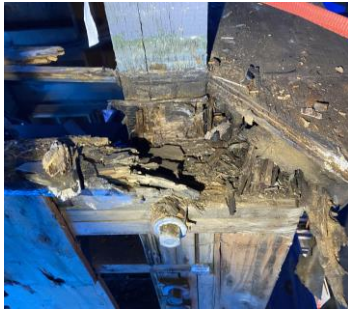
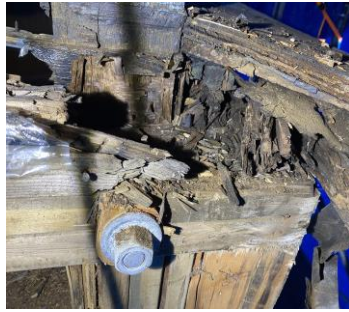
**Problem:** Due the longevity of water ingress over the years the existing structural framing at and below the timber work has sustained heavy damages. Saturation and dry rot has replaced the once strong fibres in the wood.

Some areas have turned to dust. While others have become brittle and are at a full failure capacity. All corners have sustained heavy damages.(x4).

**Solution:** Reframe and upgrade to meet all required structural requirements and BC Building Codes.
